GRAEF Project No.: 2013-0167

Tropical, Desert, and Show Dome Inspection Report

Mitchell Park Horticultural
Conservatory
524 S. Layton Blvd.
Milwaukee, Wisconsin

January 9, 2015

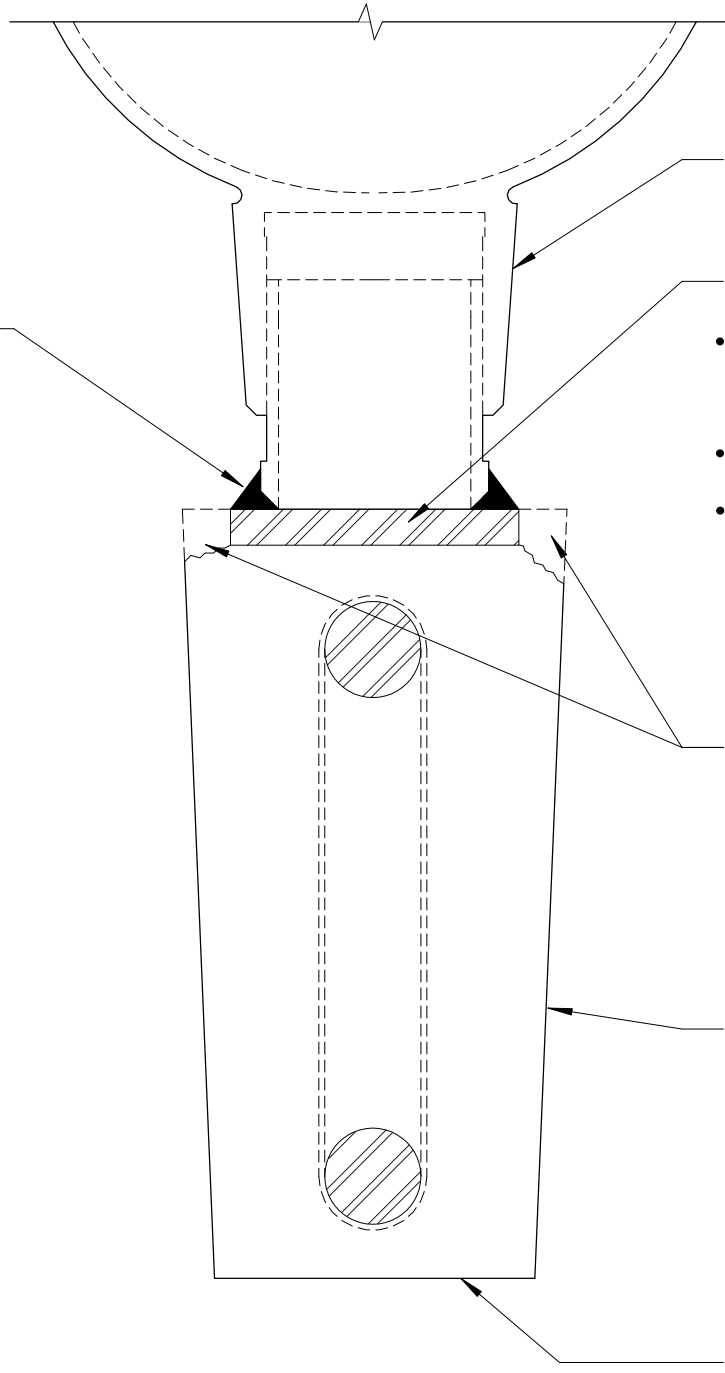
TYPICAL EXISTING
4-1" LONG WELDS
AND SEALANT
AROUND PERIMETER
OF GLAZING HUB.

EXISTING ALUMINUM AND
STAINLESS STEEL GLAZING
HUB CONNECTION.

TYPICAL EXISTING 3"x3"x3/8"
STEEL PLATE CAST INTO BEAM.

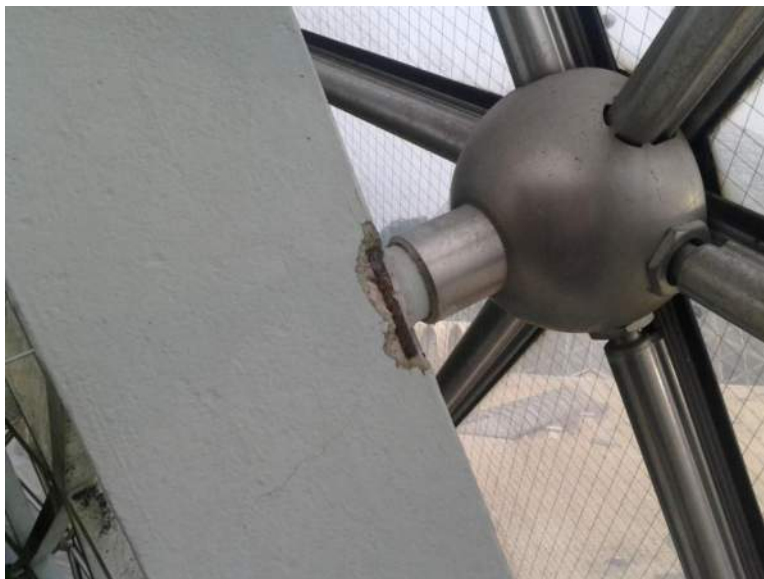
Photo F01: VISIBLE CONCRETE CRACKING AT CONNECTION OF GLAZING STANDOFF PIPE TO STRUCTURAL SPACE FRAME.

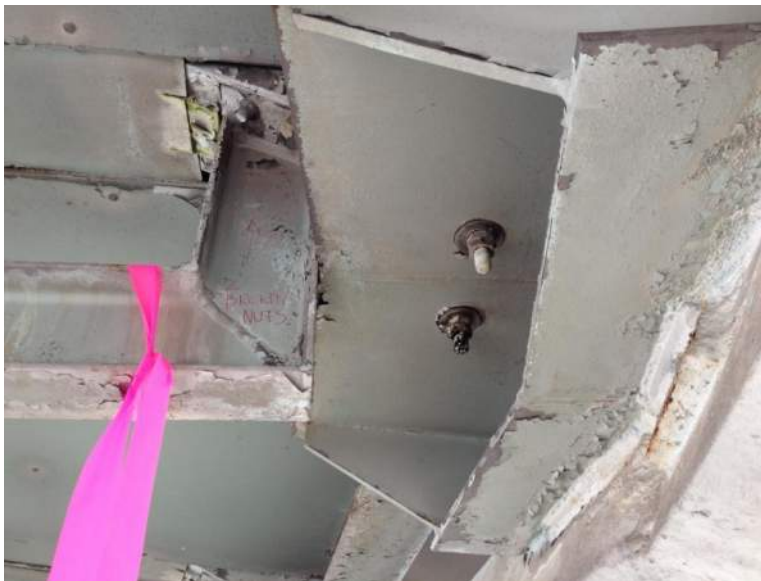
Photo F09: ALUMINUM FRAMING AT DOME APEX CONNECTS TO COMPRESSION RING OF REINFORCED CONCRETE SPACE FRAME DOME.
